Arkansas Natural Resources Commission

November 19, 2015

RE: INSPECTION: PERMIT 299 -- LAKE ERLING DAM – LAFAYETTE CO.

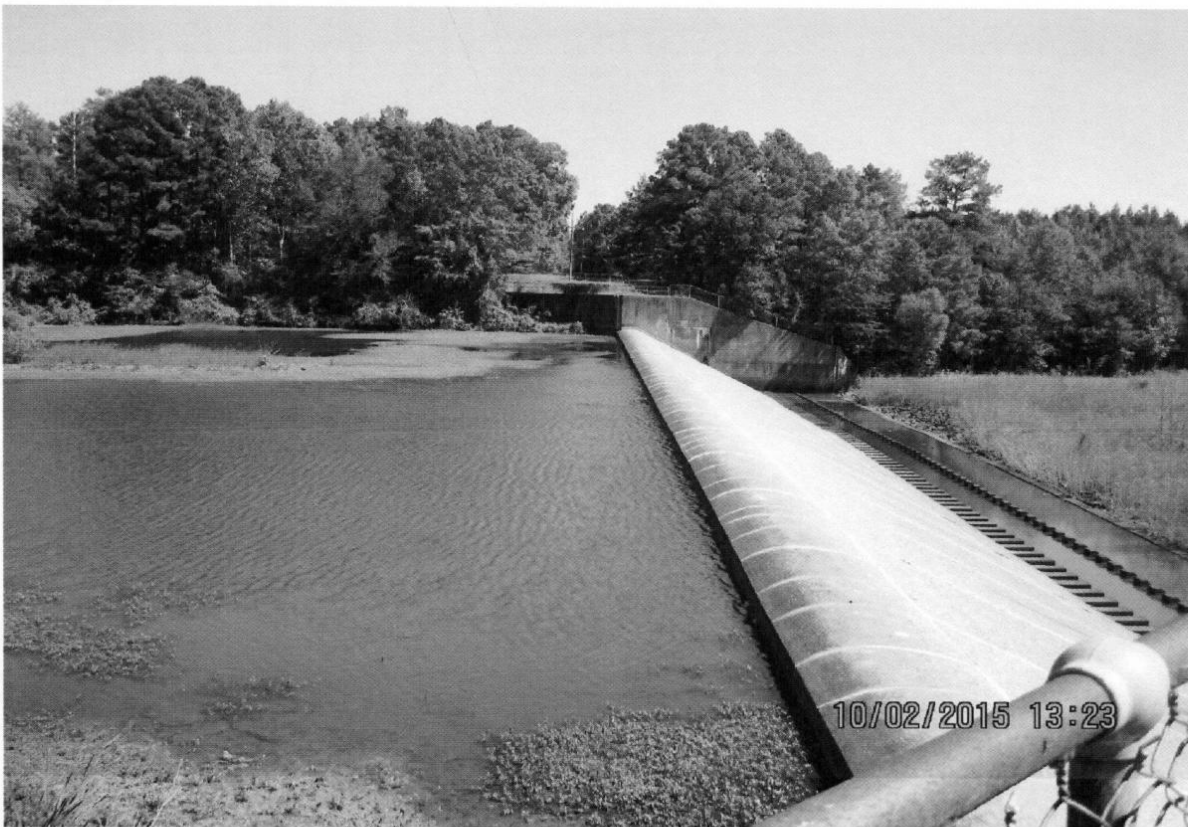
Beyond the presence of the staff gage in the auxiliary spillway I am not aware of any instrumentation or monitoring other than regular visits by your staff. This is not necessarily a shortcoming, merely an observation. It has not prevented the dam from maintaining an excellent record of performance and maintenance up to this date and I do not envision it doing so in the future.

Figure 1 Auxiliary spillway crest

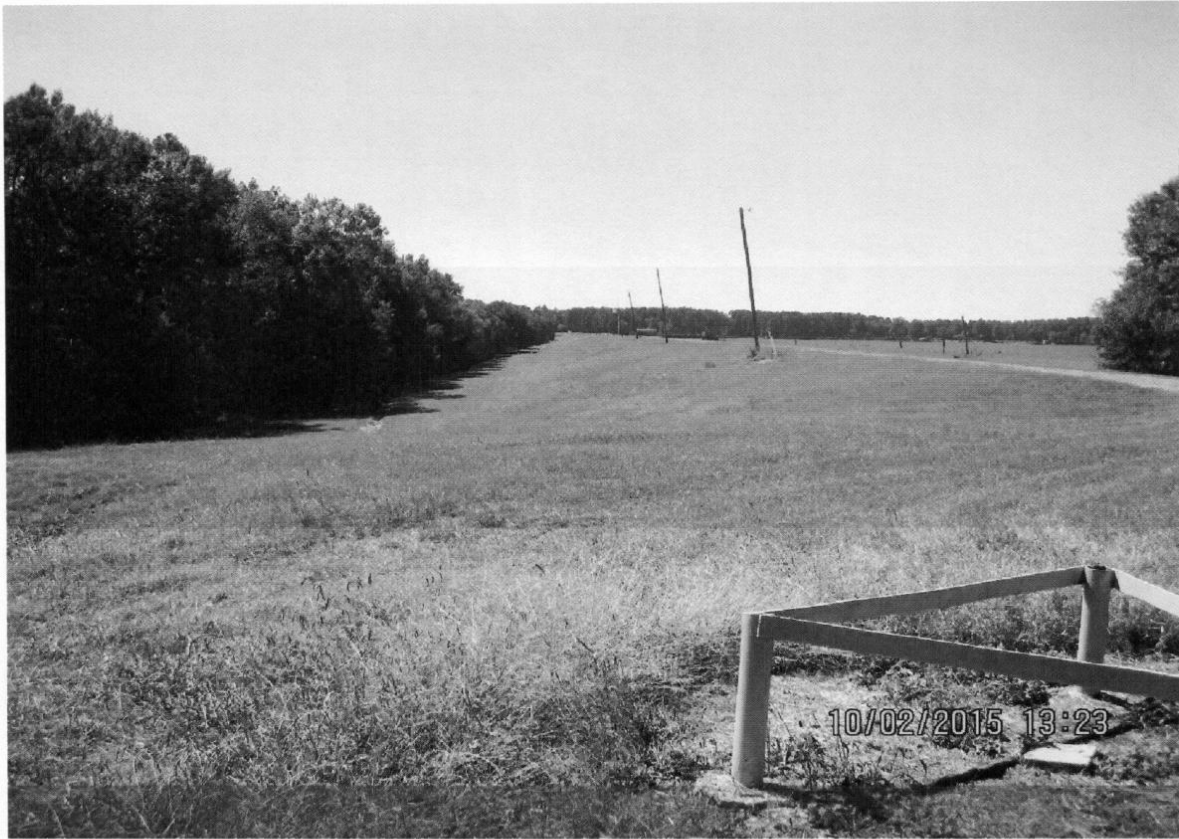
The crest and downstream slope had no observable issues which would indicate any structural deficiencies, erosion concerns or maintenance shortcomings are present.

Figure 2 Downstream slope and crest

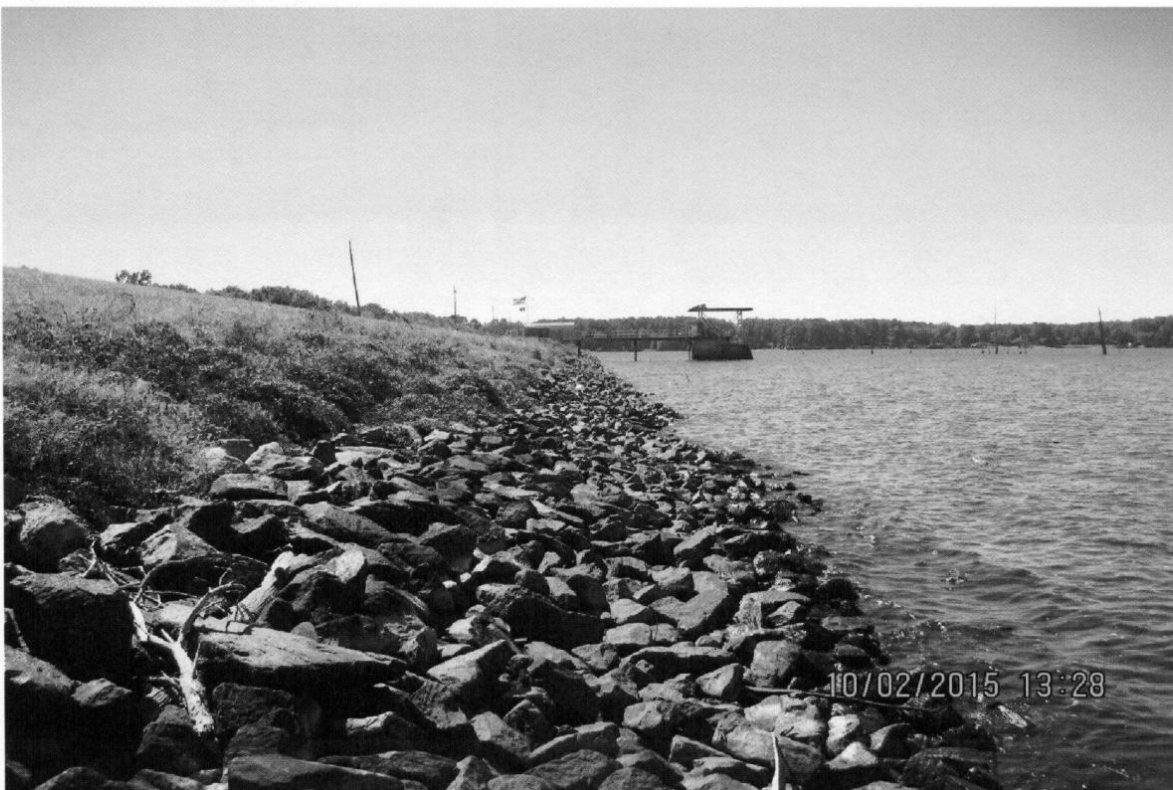
As has been typical with the maintenance of this structure, the upstream slope demonstrated a healthy covering of appropriate vegetation. The small deviations in the observable line of riprap are still present, but I do not believe the energy dissipating effectiveness is lessened by the current condition.

Figure 3 Upstream slope
